## O' Donovan Engineering, Coachford, Co. Cork

### Inclusion in the EcoBusiness Programme

## Environmental Improvements Made

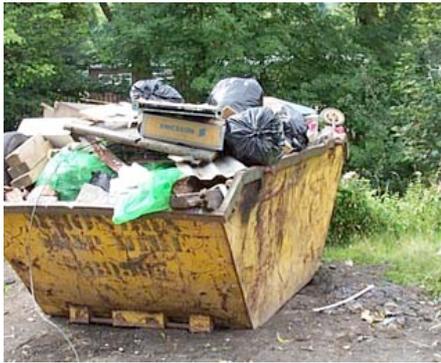
**One of the first areas tackled at O' Donovan Engineering was the issue of mixed wastes**

Large open skip should be removed and replaced with 1100l bin. Improve waste segregation on site. Store cardboard bales in a suitable location out of the weather.

The skip was removed and replaced with a 1100 L bin. On removing the skip completely the charges dropped significantly. This was attributed to:

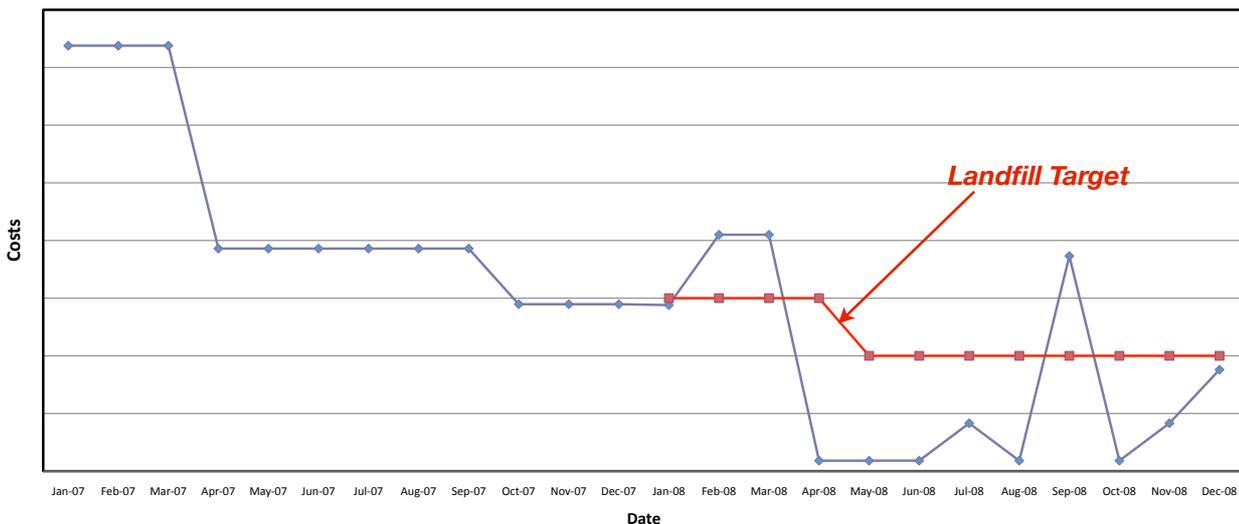
**Landfill Waste Costs**

The waste profile shown above reflects massive monthly savings achieved in the cost of mixed waste disposal. Initially waste charges for the skip were the same each month, irrespective of volumes. The waste skip was collected on a monthly basis, regardless of whether it was full. The system was changed so that the skip was only collected upon request from the company, resulting

There are now colour coded drums around the site for the segregation of different process materials. In addition the maintenance manager has ensured a very high level of waste segregation. More recently charges have gone up but this is due to a reclassification of a previously recycled stream. **Annual savings of almost €4000 were made in the first year.**

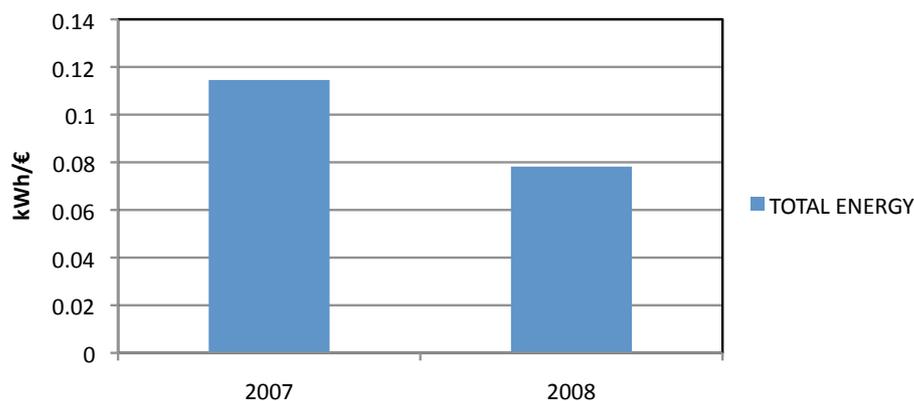
## Total Energy Use per Unit Turnover

The following figure shows the comparison of energy use with turnover. This profile shows that the energy efficiency of the business relative to unit turnover improved by ~ 33% between 2007 and 2008. During this time some of the process work was subcontracted out. This value was subtracted from the turnover so that like was compared with like. Also, between '07 and '08

business activity and energy consumption increased. While total energy costs increased by 19%, the overall ratio of energy cost to turnover reduced by 33%.
